Tech Notes

MILLS NOS. 5, 6 and 8 Suffolk Manufacturing Company (Wannalancit Office and Technology Center) Lowell, Massachusetts

Aluminum Replacement Windows with Sealed Insulating Glass and Trapezoidal Muntin Grids

PTN-15

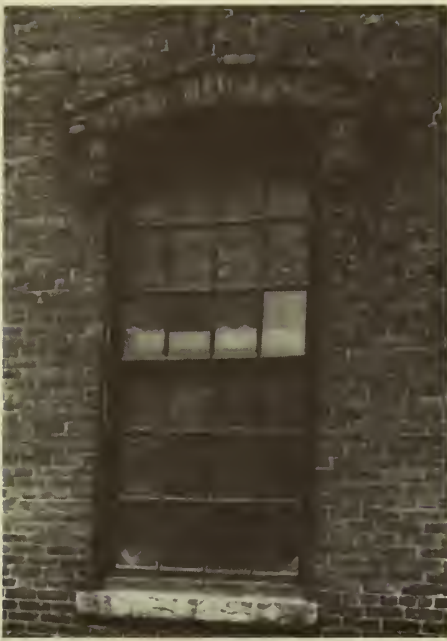
Figure 1. The original wooden double-hung windows consisted of 12 lights in both the upper and lower sash. Photo: Charles Parrott

The long unbroken pattern of some 900 small-paned windows dominates the facades of these buildings and is clearly their most significant architectural element. At the time of the conversion to an office complex, the original double-hung windows, arranged with 12-over-12 lights, had survived in Mills Nos. 6 and 8, but virtually all the sash and some of the frames had been removed from Mill No. 5 (see figure 1).

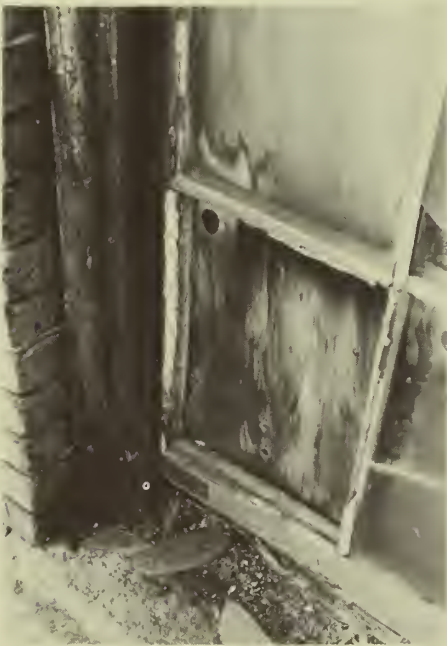
Figure 2. The condition of the windows varied considerably. Shown here is a typical case where the frame, sill and sash were beyond repair. Photo: Charles Fisher

The first step was to evaluate the condition of the original windows that had survived in Mills Nos. 6 and 8 to establish whether the historic windows were repairable. Based on an indepth inspection, the windows were judged beyond reasonable repair due to their deteriorated condition (see figure 2). Once the decision to replace the historic sash had been reached, consideration was given to replacing them with matching custom-made wooden windows. The developers obtained a quotation of \$875 per window for fabrication and installation of 900 matching wooden replacement units, with integral muntins in a 12 light configuration and the addition of an interior storm panel. Due to cost, the developers decided to consider other alternatives.

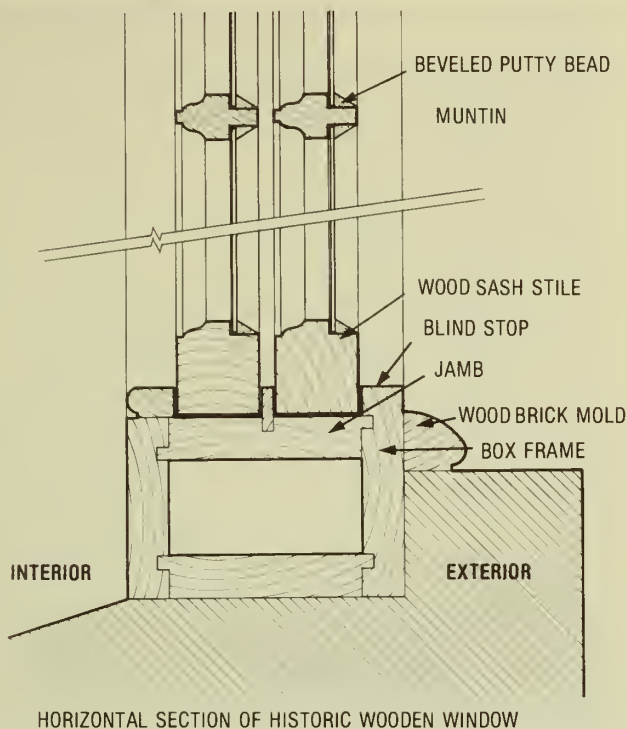
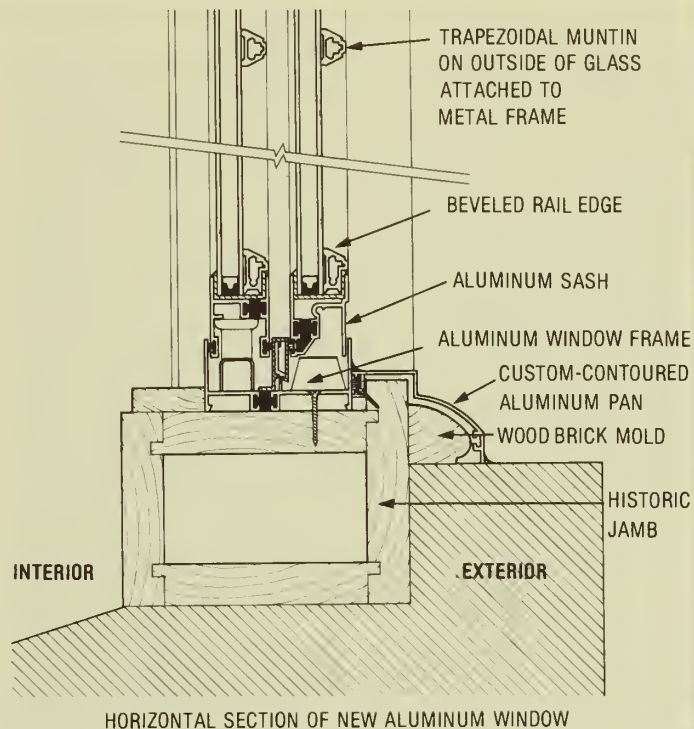
Figure 3. Horizontal section of both the original wooden window and the replacement aluminum window. Drawings: Penelope Watson

The historic wooden frames were retained and used as a structural sub-frame on which to fasten the new aluminum trim and frame members. A custom extruded aluminum pan was used that fitted snugly around the exposed face of the original frame and maintained the face width and depth of the casing at both jamb and head. The original wooden brick molding (which covers the joint between the masonry and the window frame) was fitted with a custom-extruded aluminum pan (see figure 3).

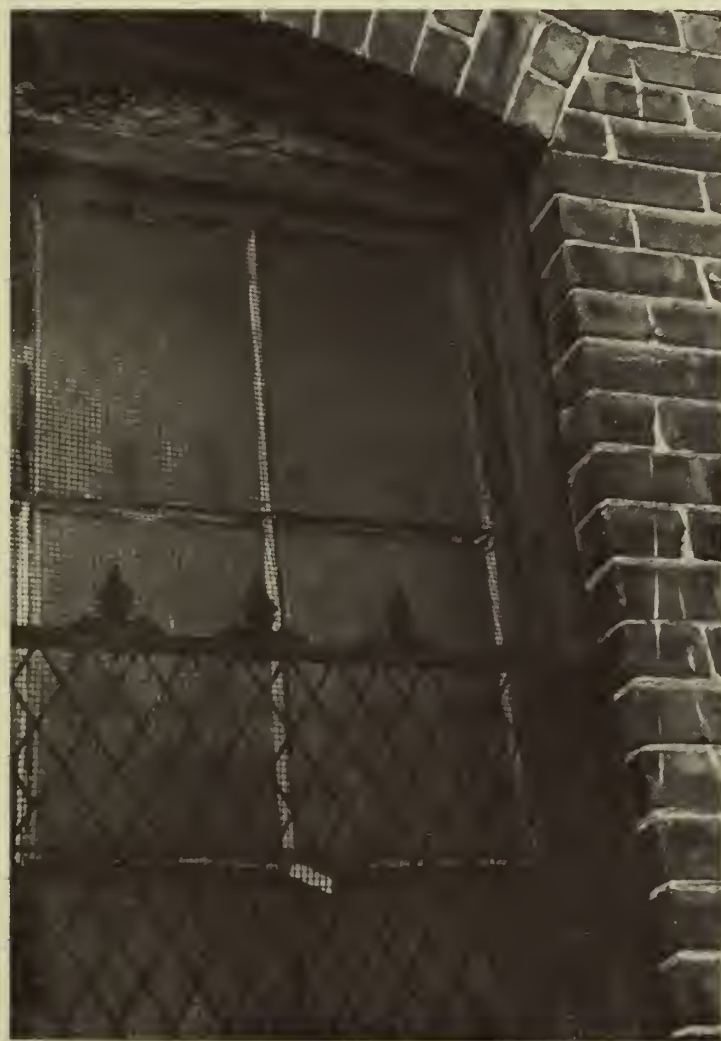
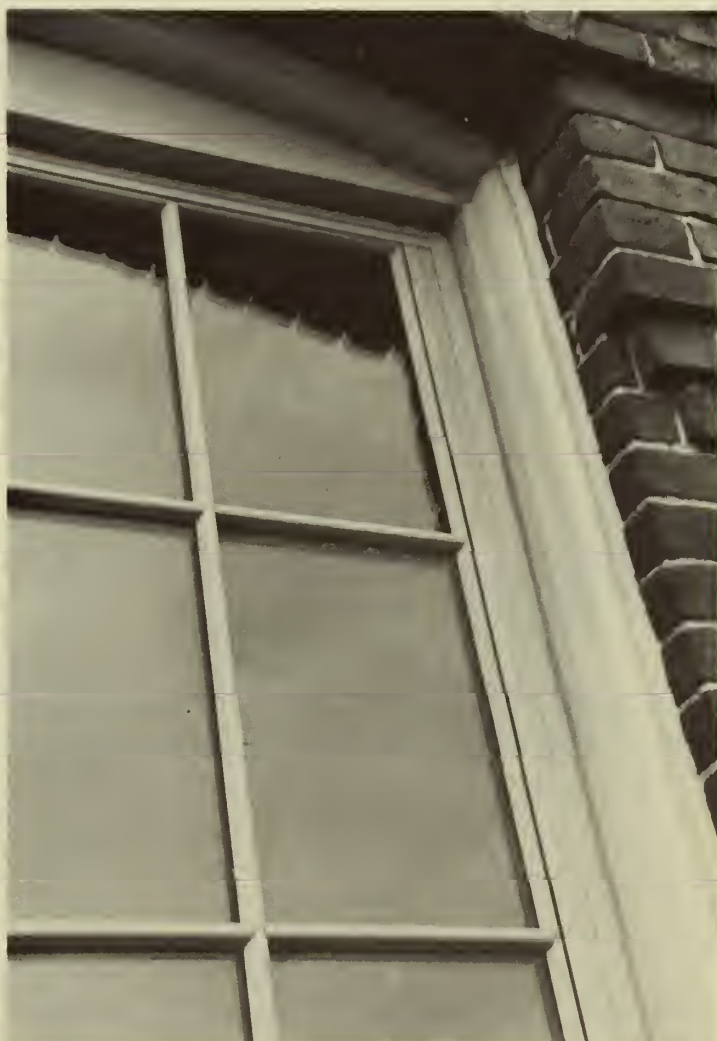
Figure 4. A custom-extruded aluminum pan was installed, duplicating the brick molding detail and, at the head of the frame, custom bent to follow the segmental curve of the masonry opening. Photos: Charles Fisher

At the head of the wooden frame, the aluminum pan was constructed in two pieces, both custom extrusions. The flat face of the lower piece was cut on a curve to follow the segmental curve of the masonry opening. The upper piece, which replaced the original brick molding, was custom-bent to the segmental curve and blind attached to the lower piece of aluminum (see figure 4). An additional aluminum pan was fitted tightly to the original wooden window sill (see figure 5).

result, the face width of the new upper sash stiles (which visually includes the vertical face of the new aluminum frame) is wider (2 1/2" vs. 1 1/2") than the face width of the historic sash (see figure 4). At the lower sash, the new frame stands out as an additional member not present in the historic windows.

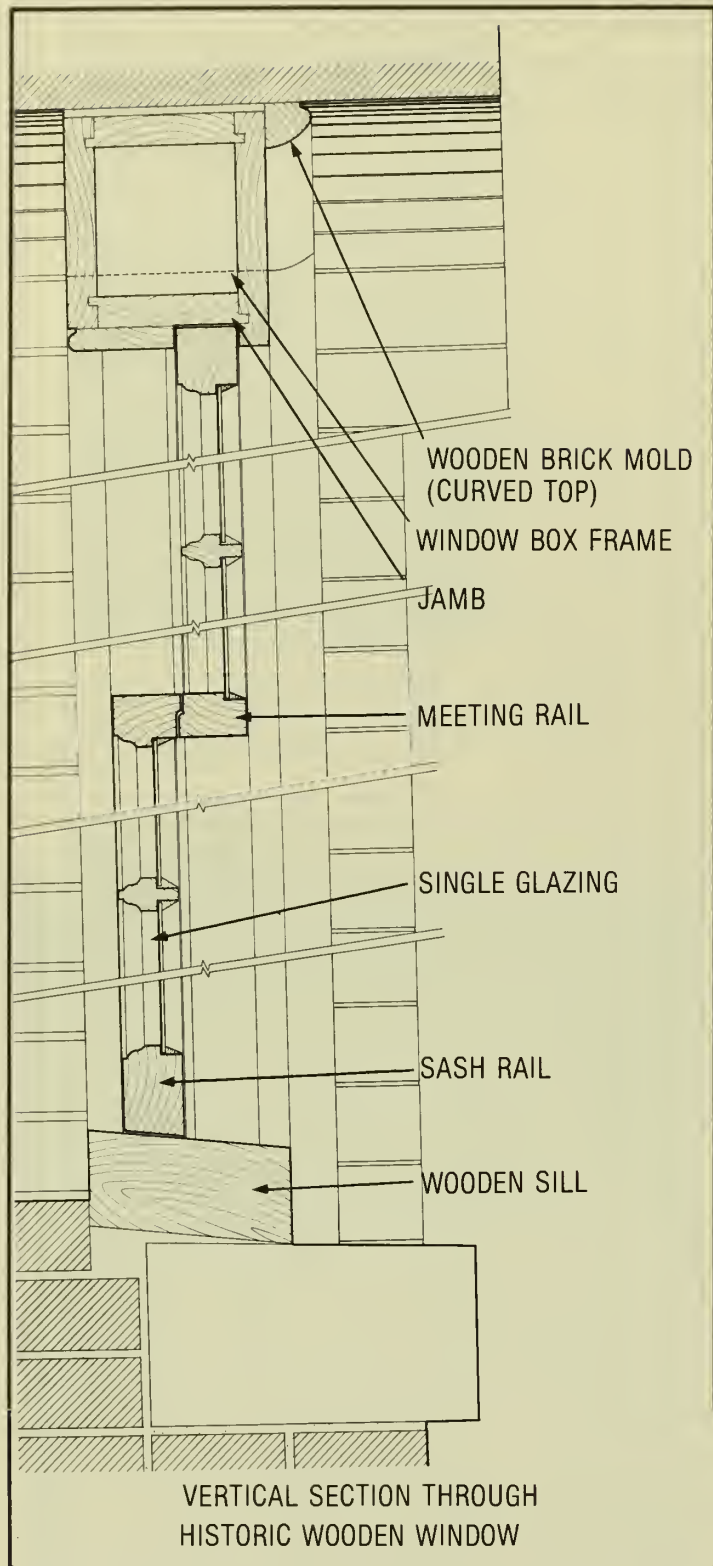
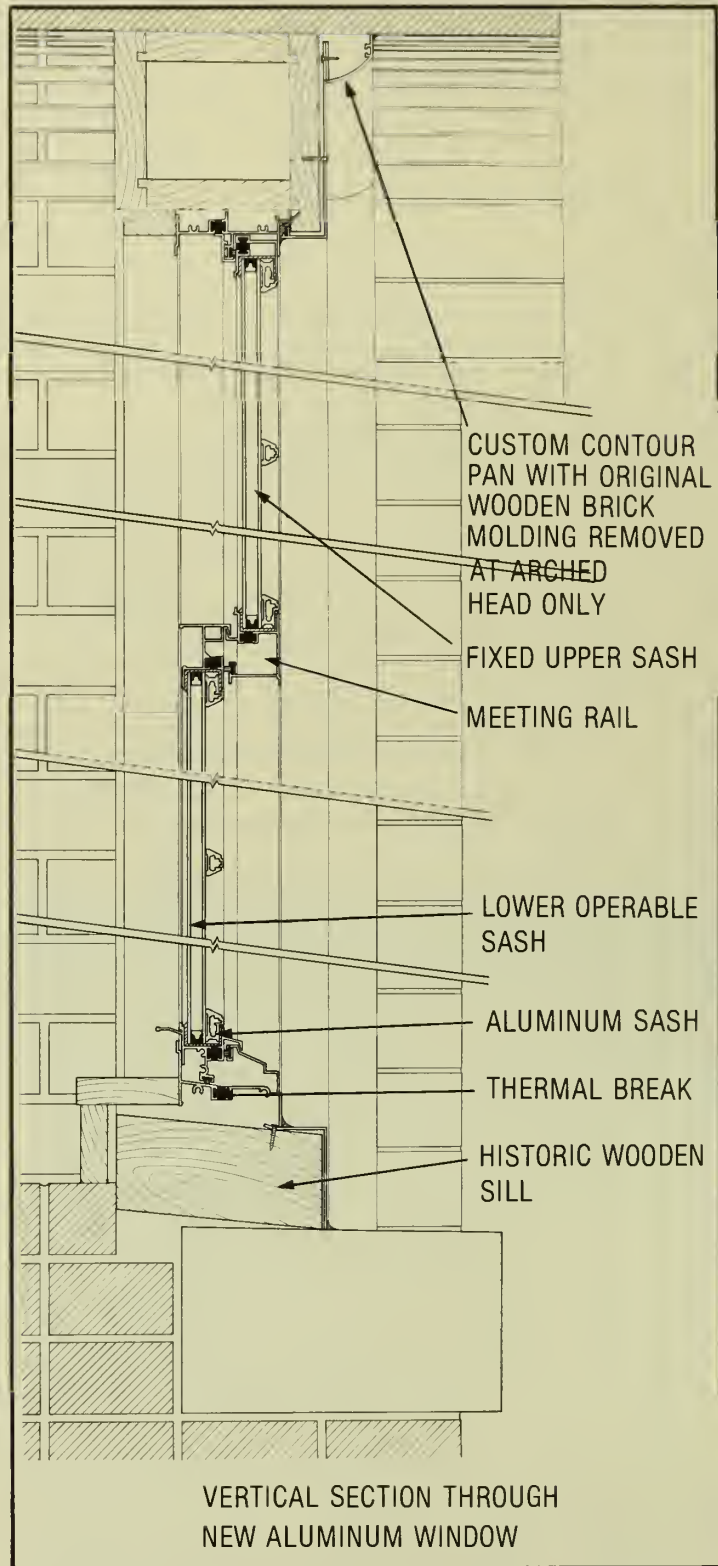
Figure 5. Vertical section of both the original wooden window and the replacement aluminum window. Drawings: Penelope Watson

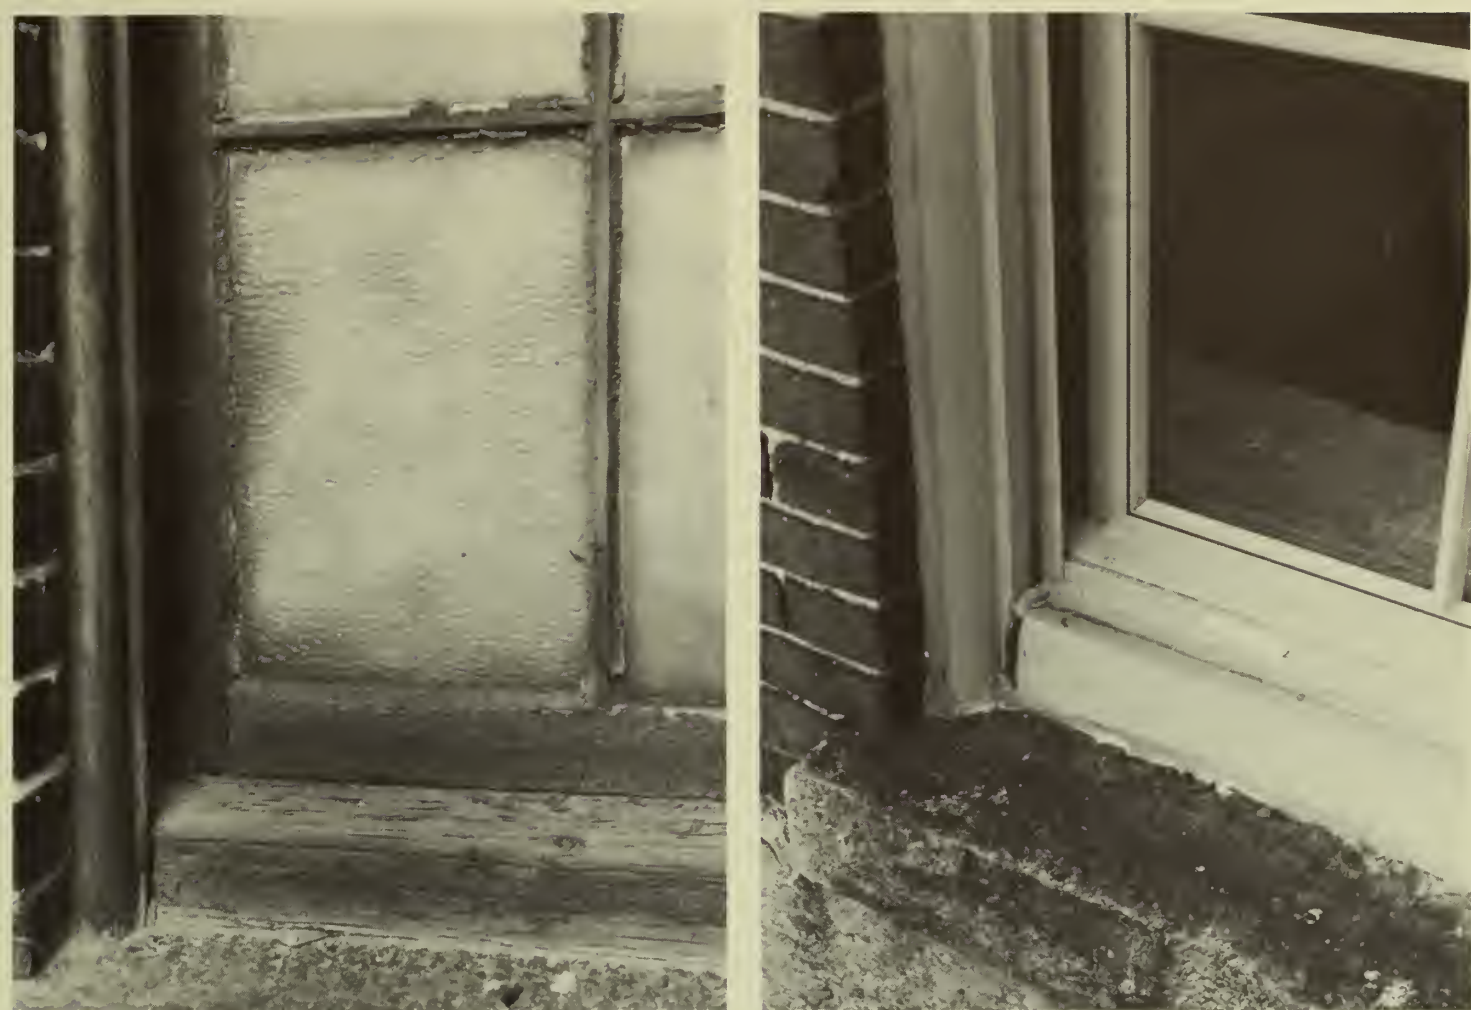
Figure 6. The manufacturer's stock window used for the project unfortunately created the appearance of a double sill, which the historic window never had. Photos: Charles Fisher

When the aluminum window frame was inserted, it included its own sill in the place where the bottom rail abutted the sill of the original window. This second sill unfortunately added an element not present in the original window (see figure 6).

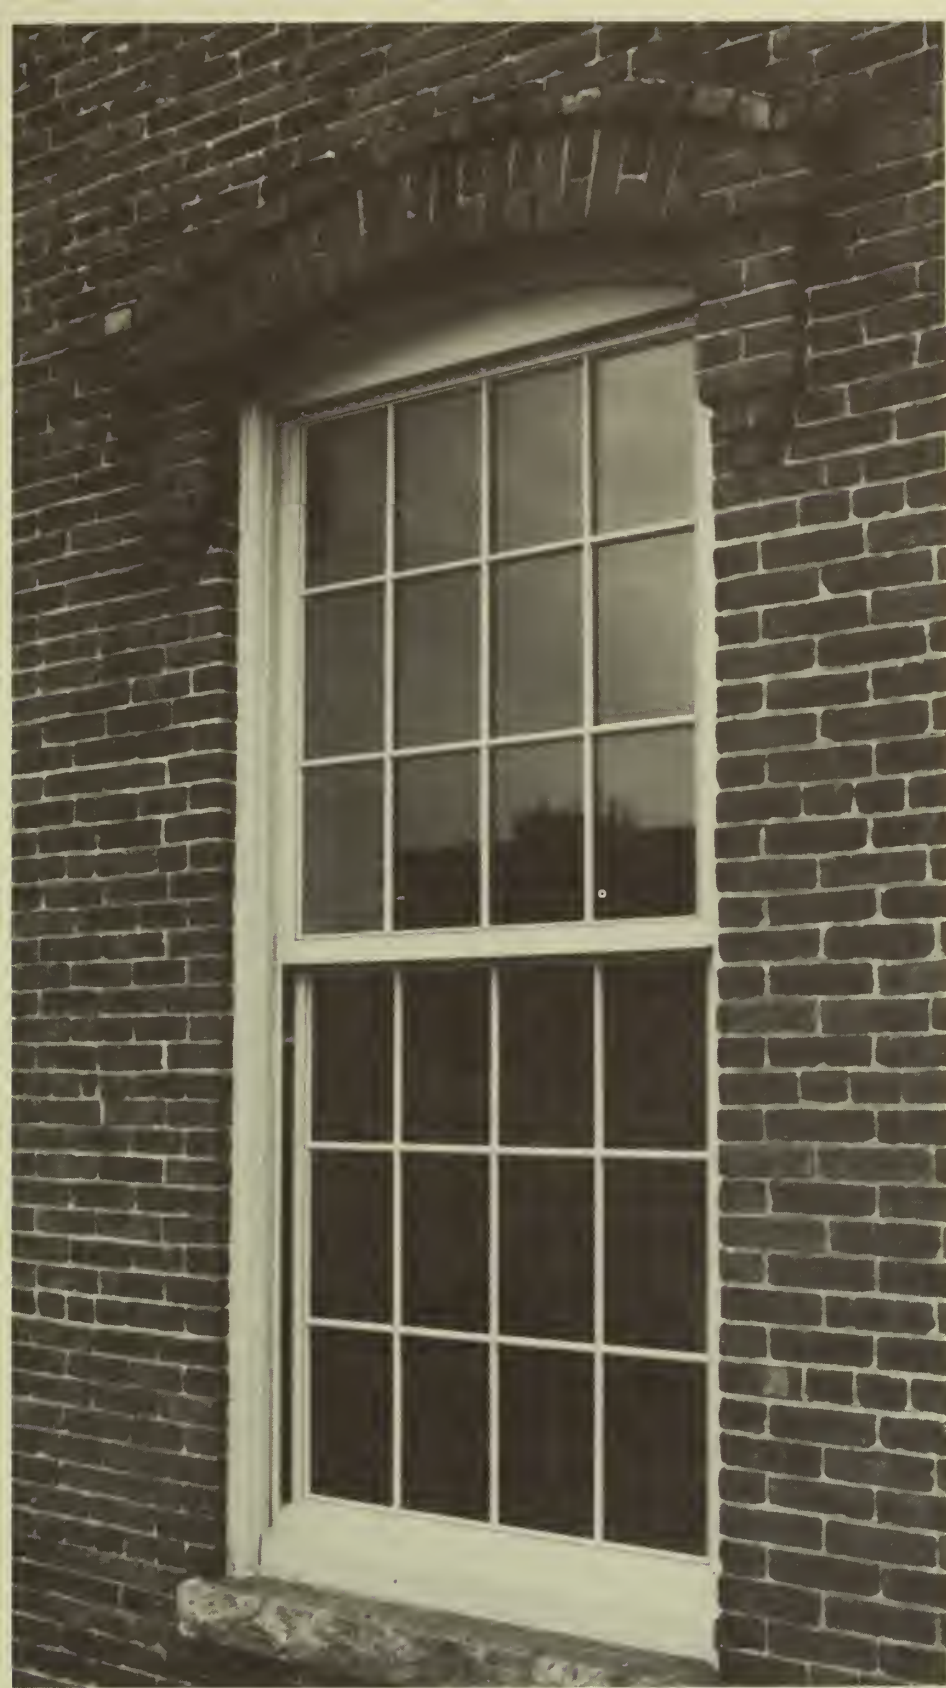
Figure 7. Replacement window after installation. Photo: Charles Parrott

For purposes of preserving the historic appearance of the building, matching the visual details of the historic wooden windows at the Suffolk Mills was of foremost importance. It was felt that the aluminum window maintained the overall appearance of the original window. This was achieved by retaining the historic frame width, using custom aluminum brick moldings (including a curved head molding), setting the two sash in offset glazing planes as in the traditional double hung window, incorporating an exterior grid on each sash simulating the trapezoidal muntins of an authentic wooden window, and using appropriate paint color (see figure 7).
